Debris/Ice/TPS Assessment And Photographic Analysis For Shuttle Mission STS-35

Gregory N. Katnik
NASA/Kennedy Space Center

DEBRIS/ICE/TPS ASSESSMENT
AND
PHOTOGRAPHIC ANALYSIS
OF
SHUTTLE MISSION STS-35

December 2, 1990

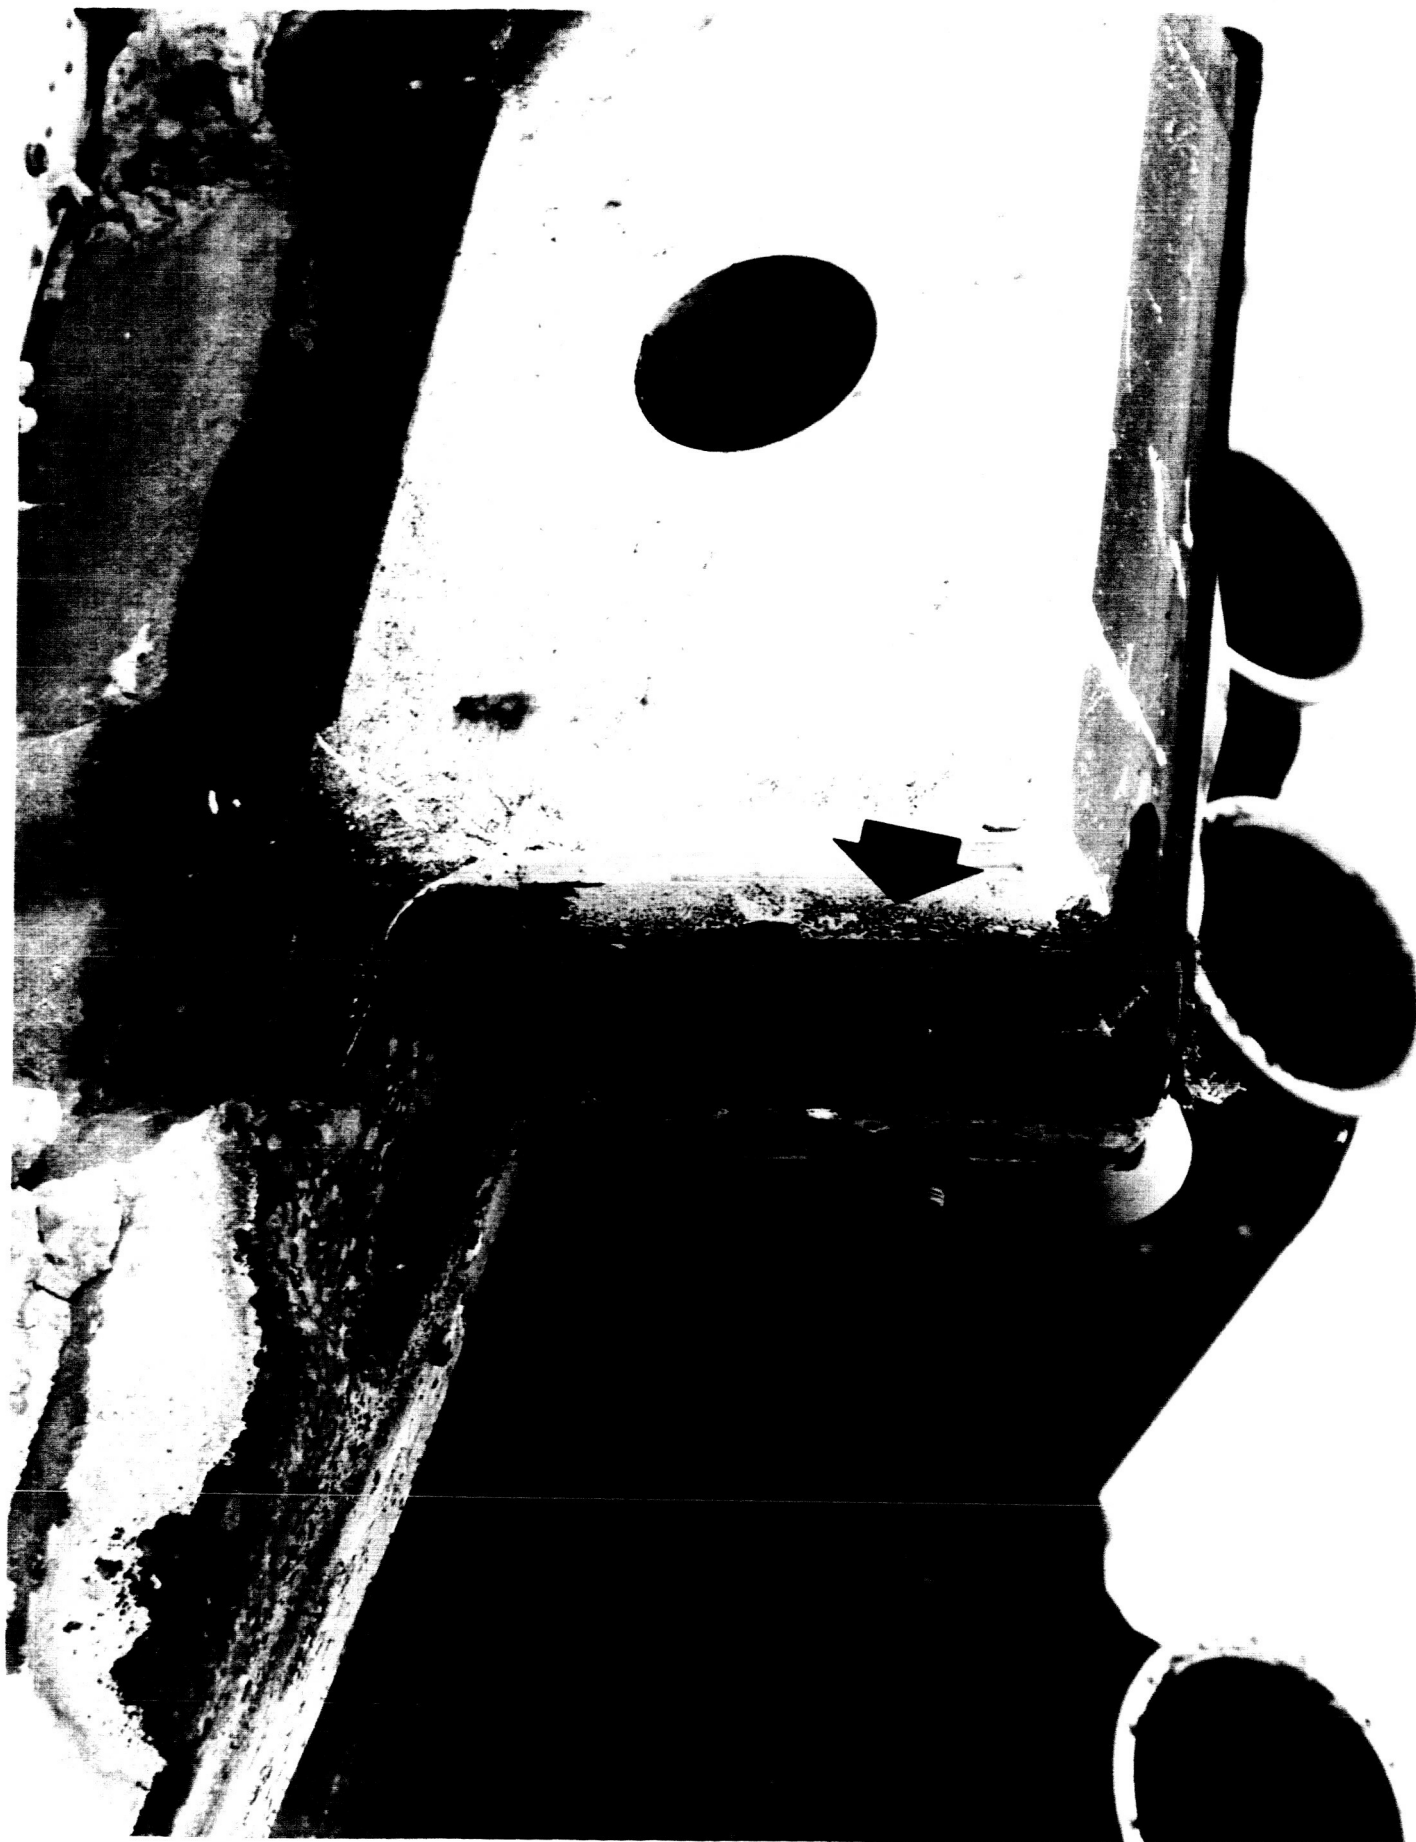
A 10"x1" piece of sidewall shim material, which should have remained bonded to the HDP #5 shoe, was found attached to the side of the aft skirt foot after retrieval.

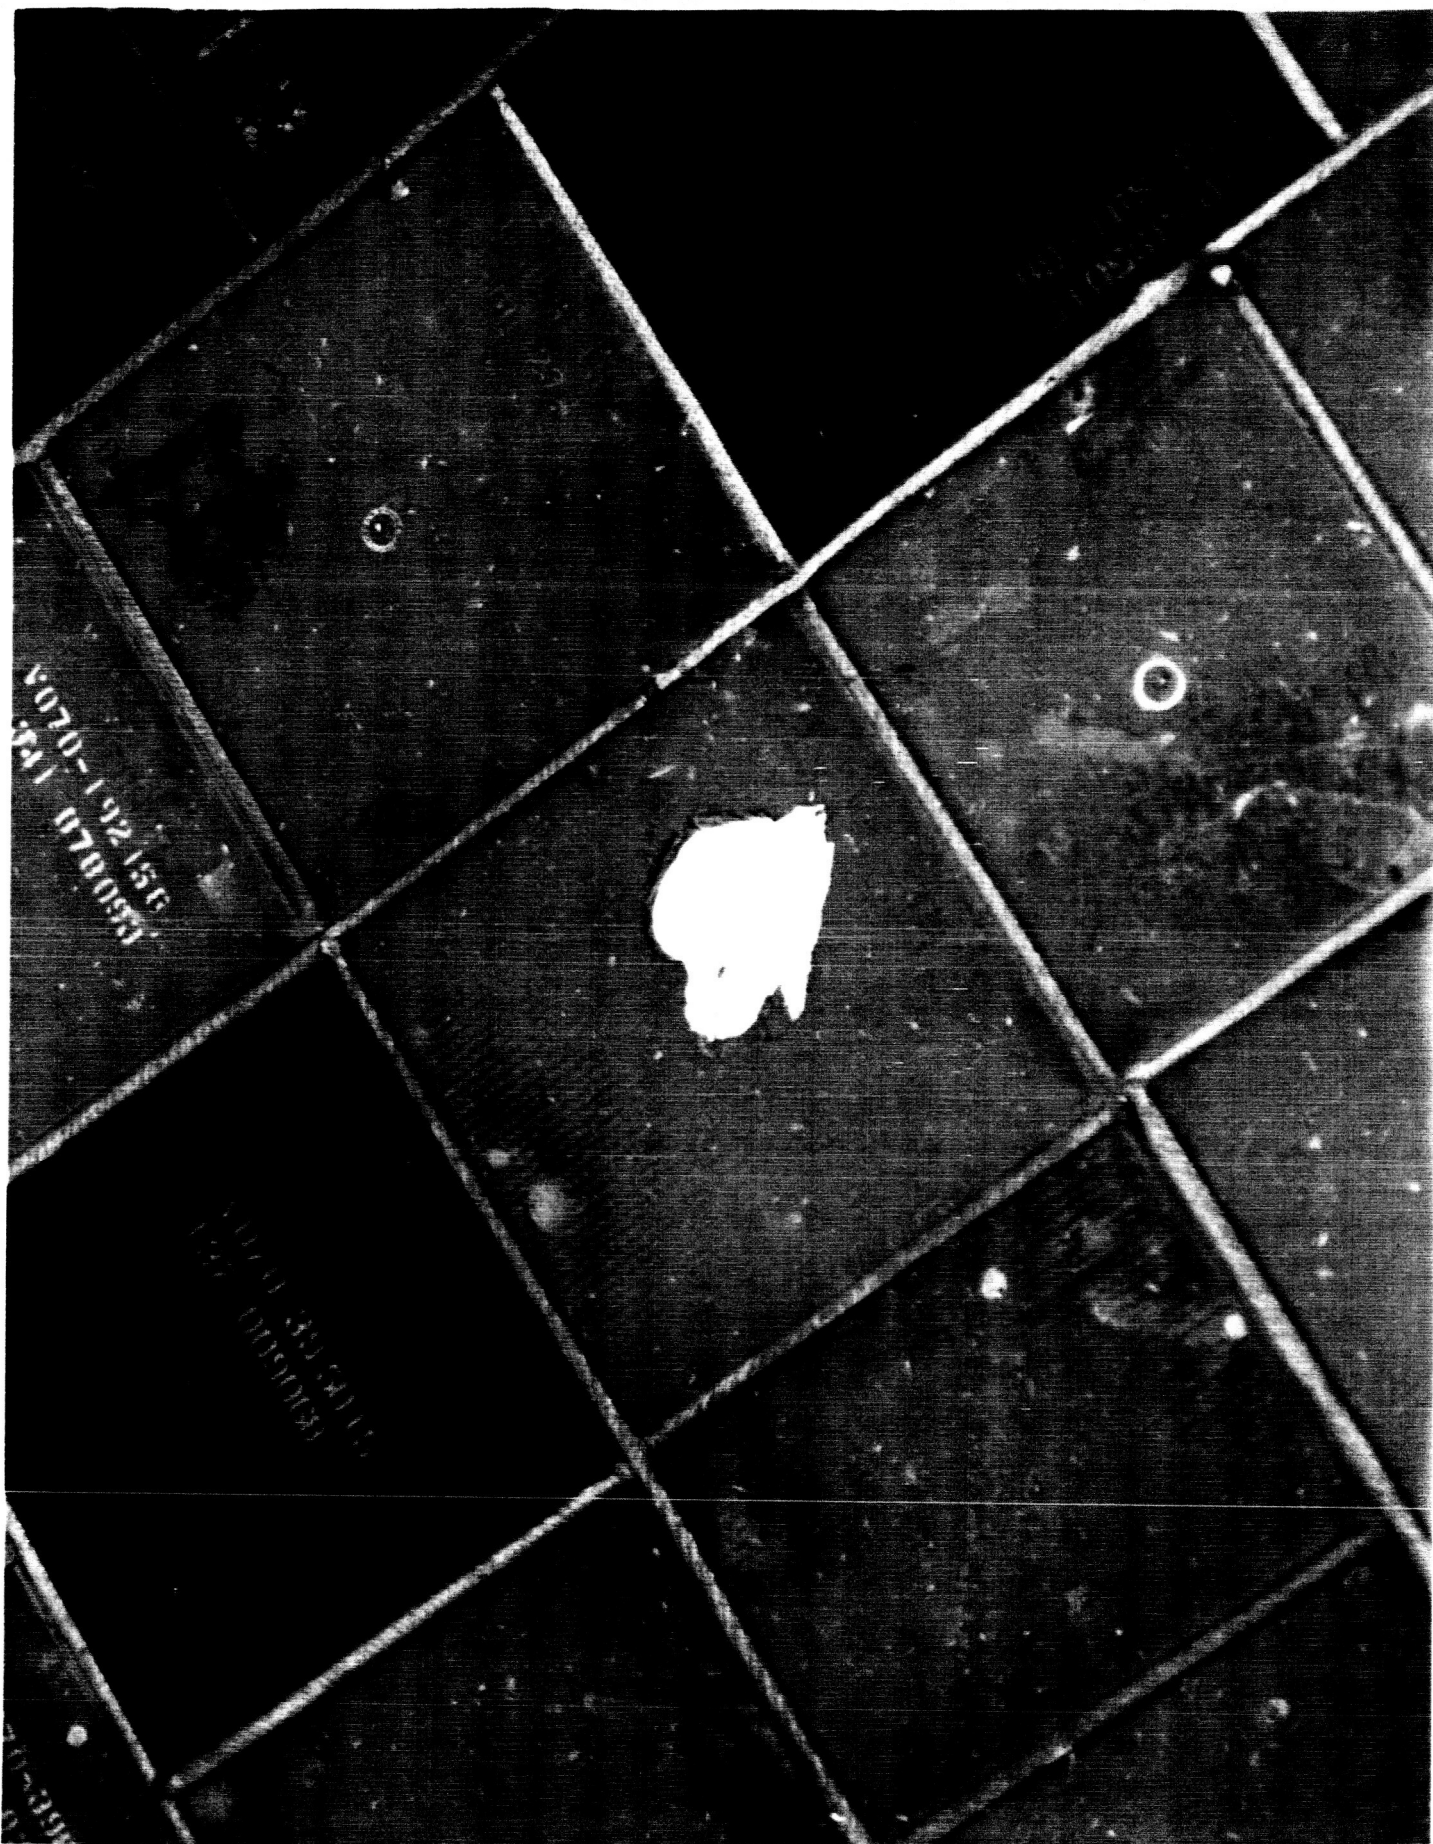
One tile damage site on the lower surface exhibited significant thermal erosion to a depth of 3/4-inch and melting of the adjacent coating material.

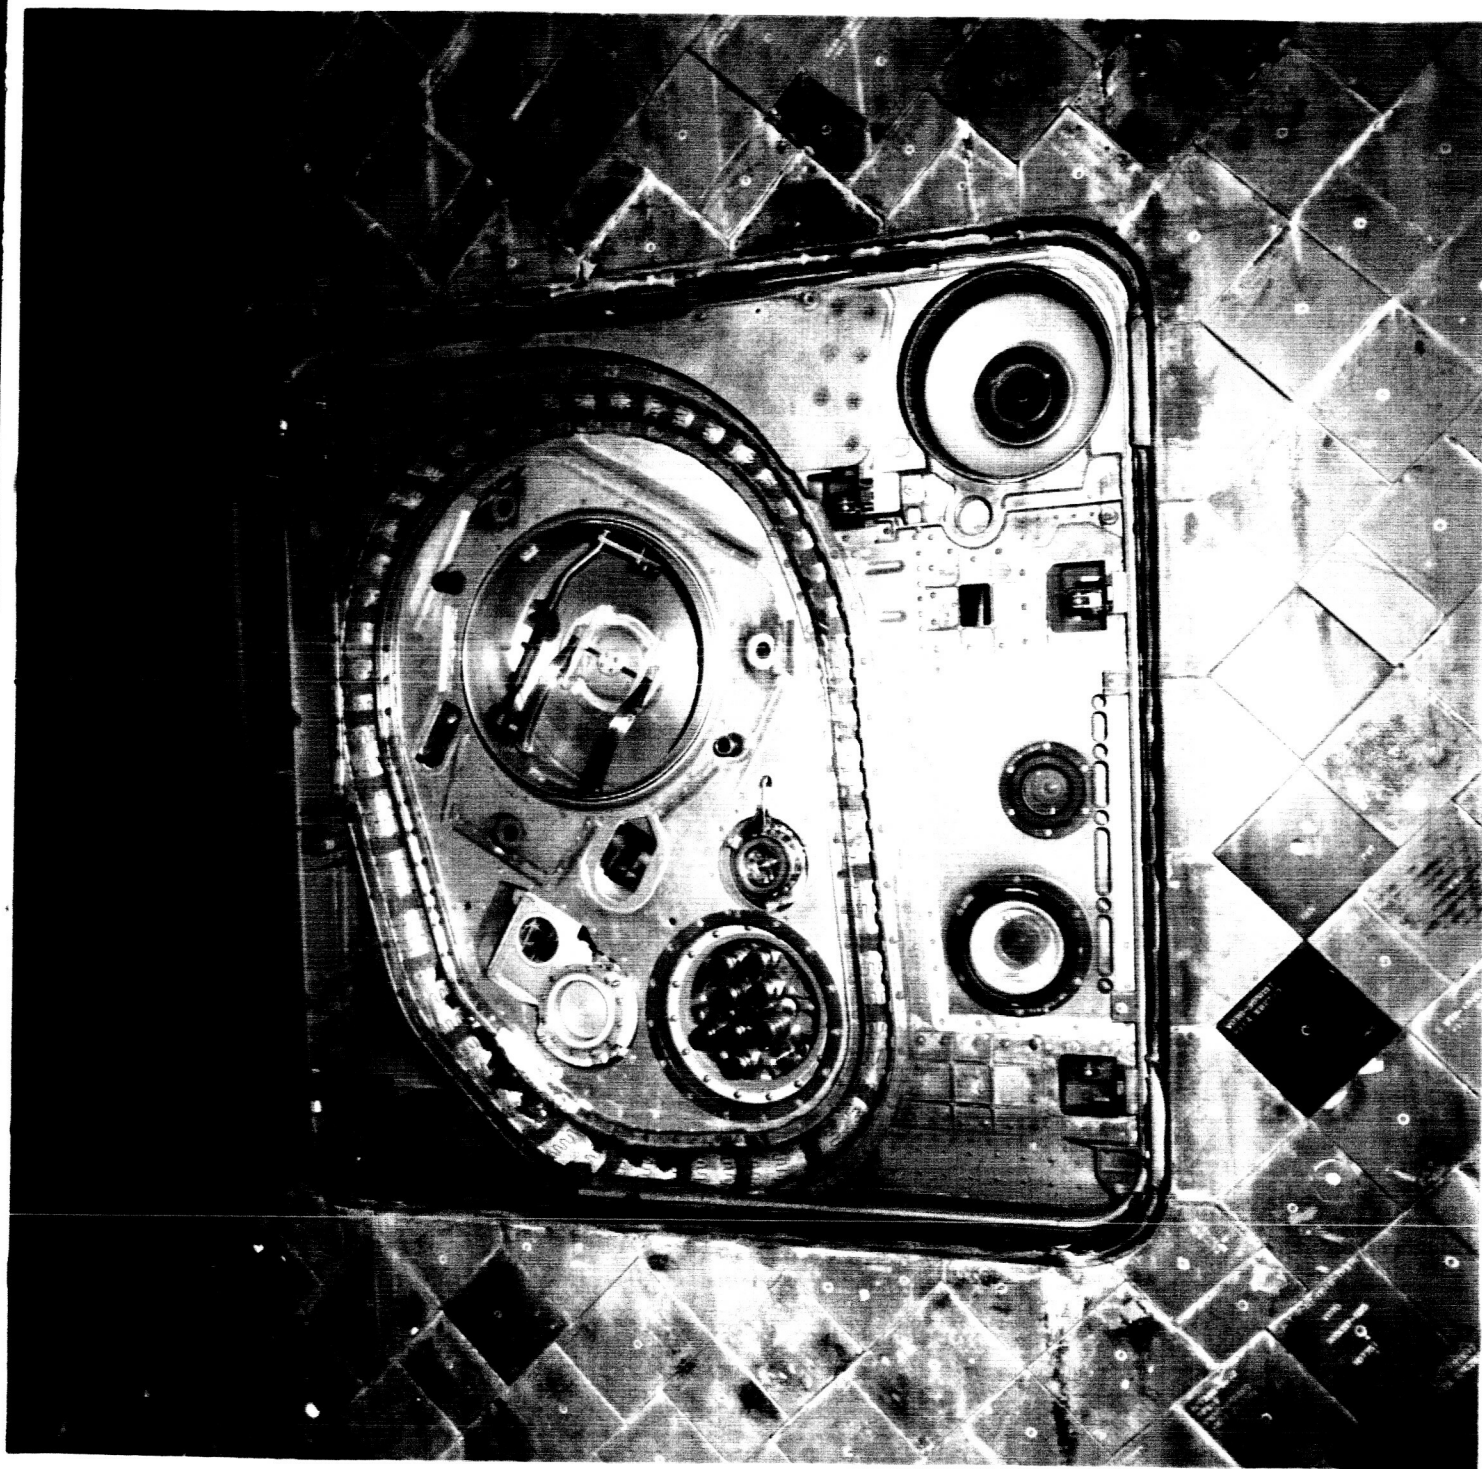
Overall view of the LH2 ET/ORB umbilical. The EO-2 separation ordnance debris plunger was seated properly.

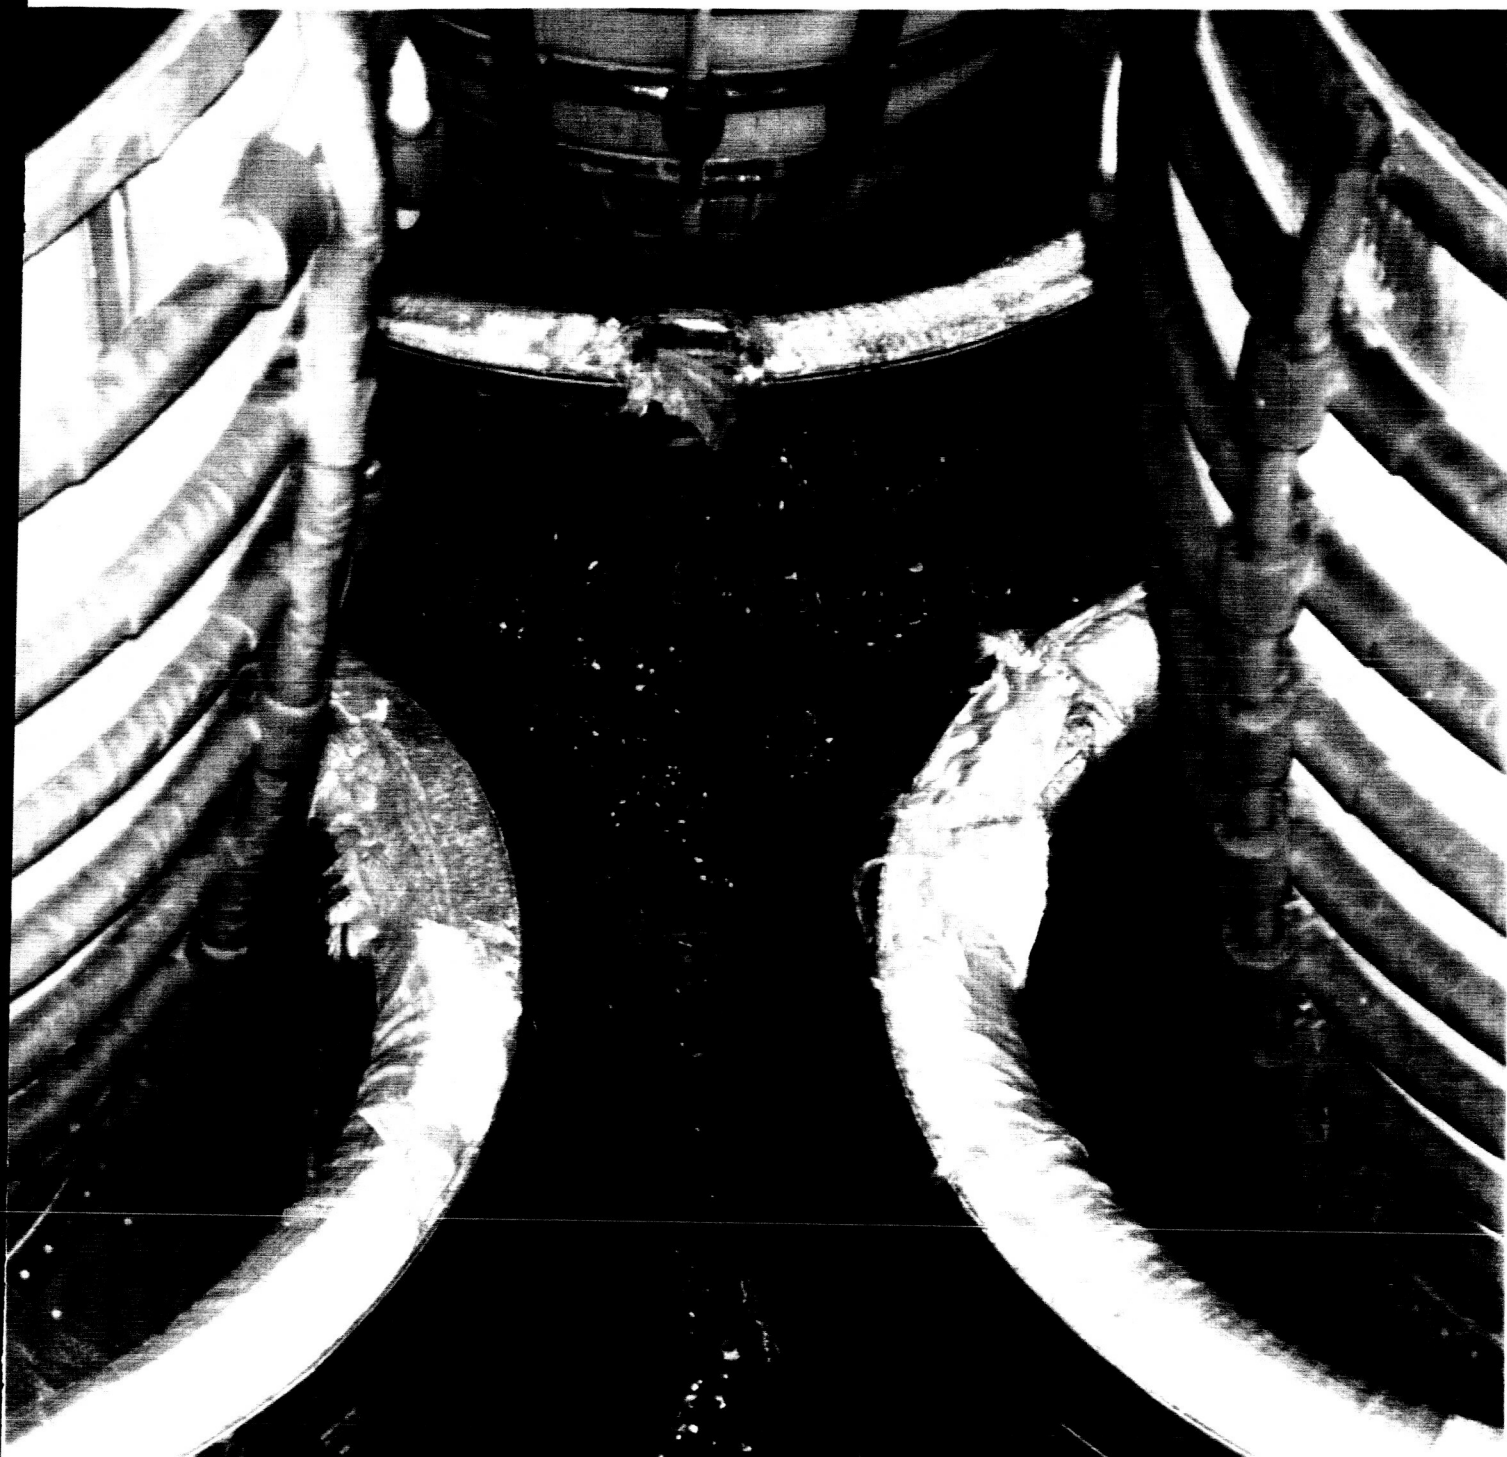
Damage to the base heat shield tiles was less than average. All three SSME closeout blankets had localized areas of peeled, frayed, and/or missing material.

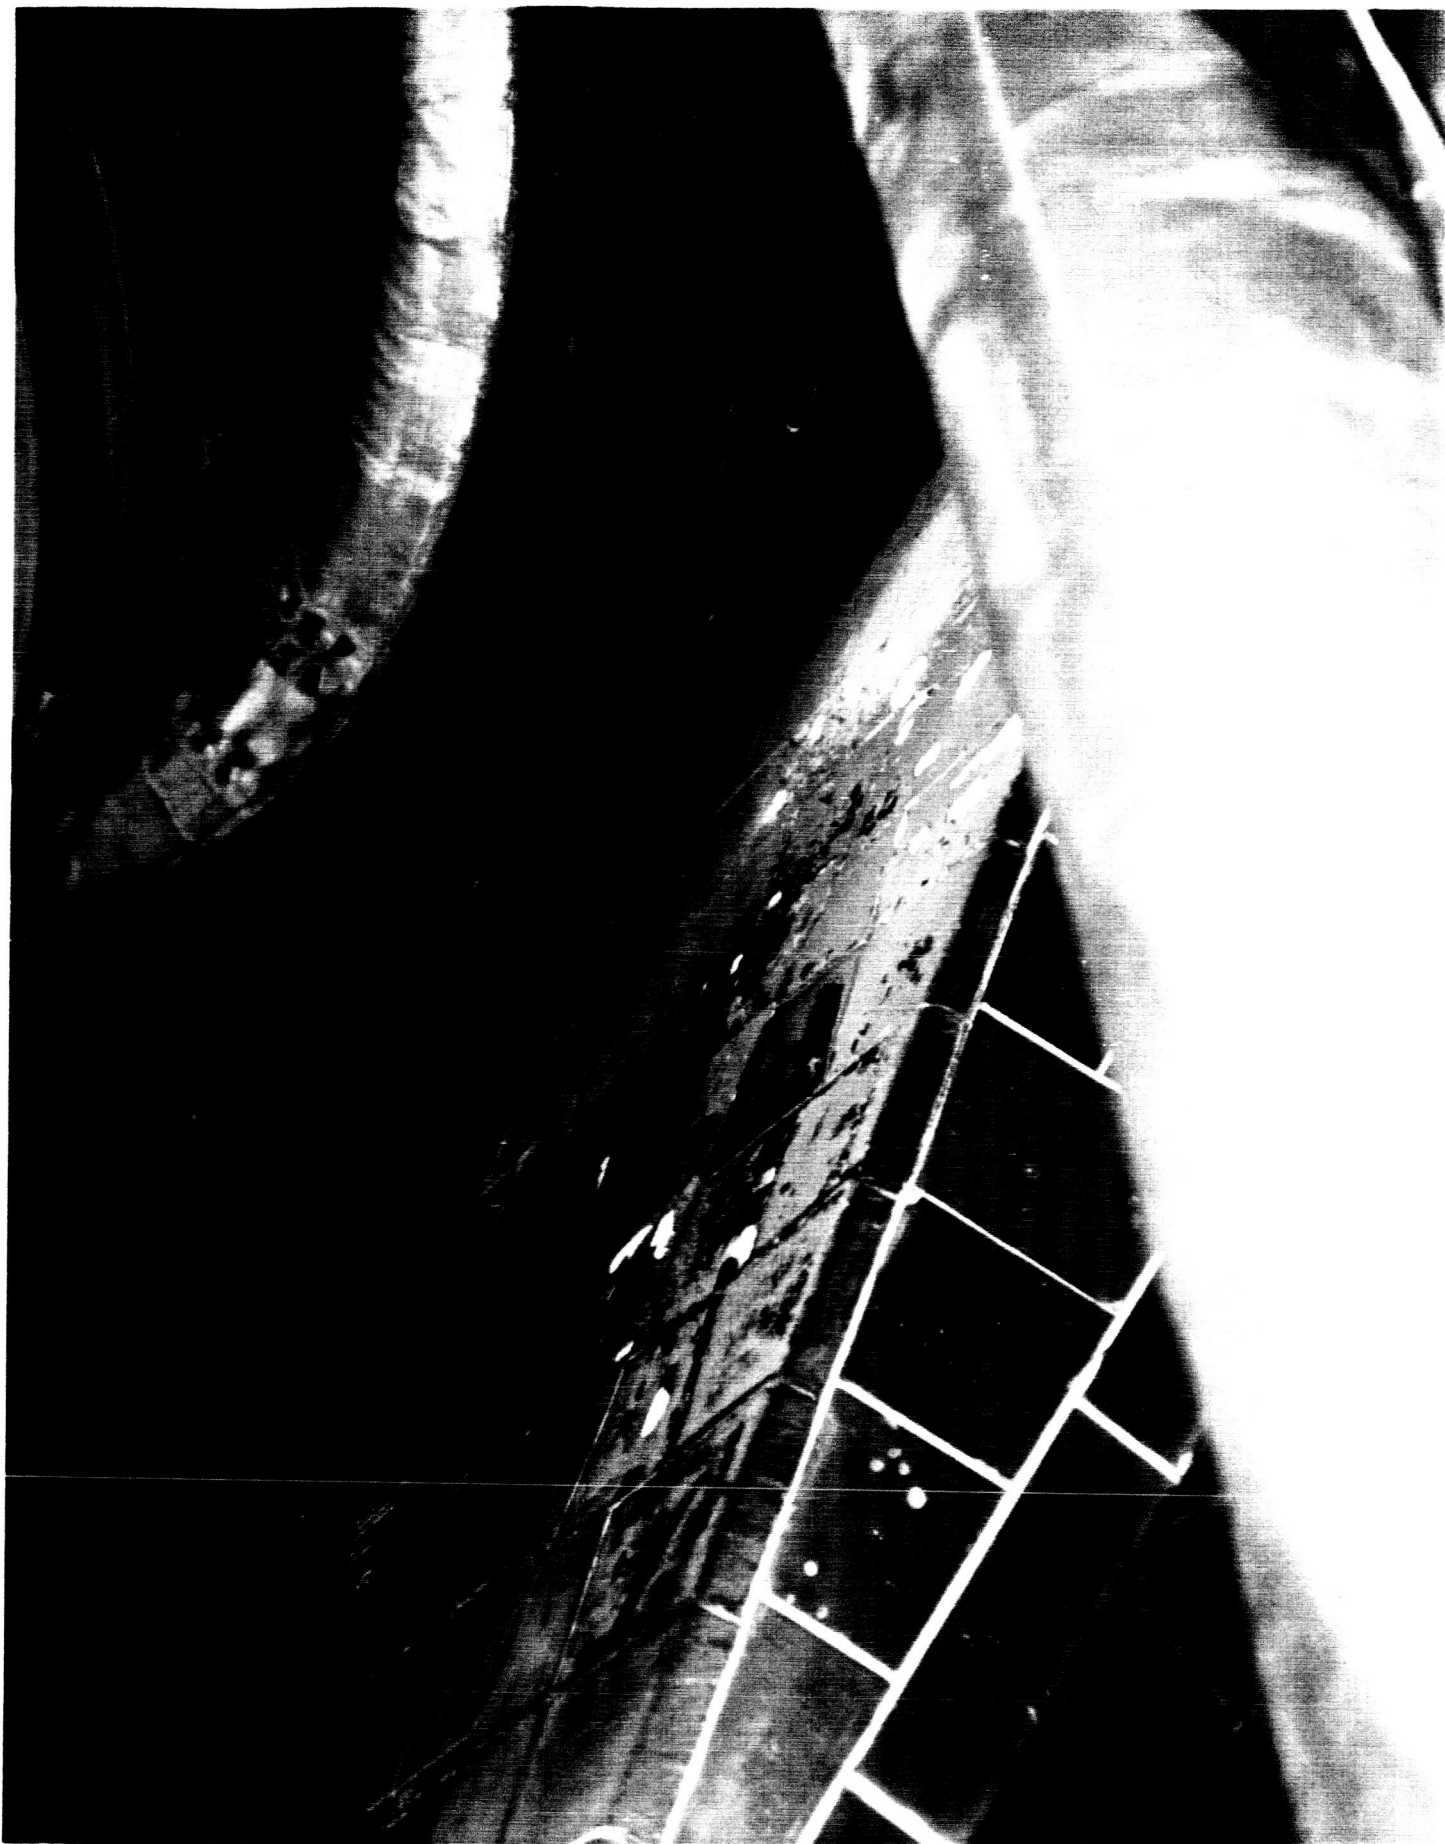
Body flap upper surface tiles sustained more damage than usual with several damage sites exhibiting significant depth

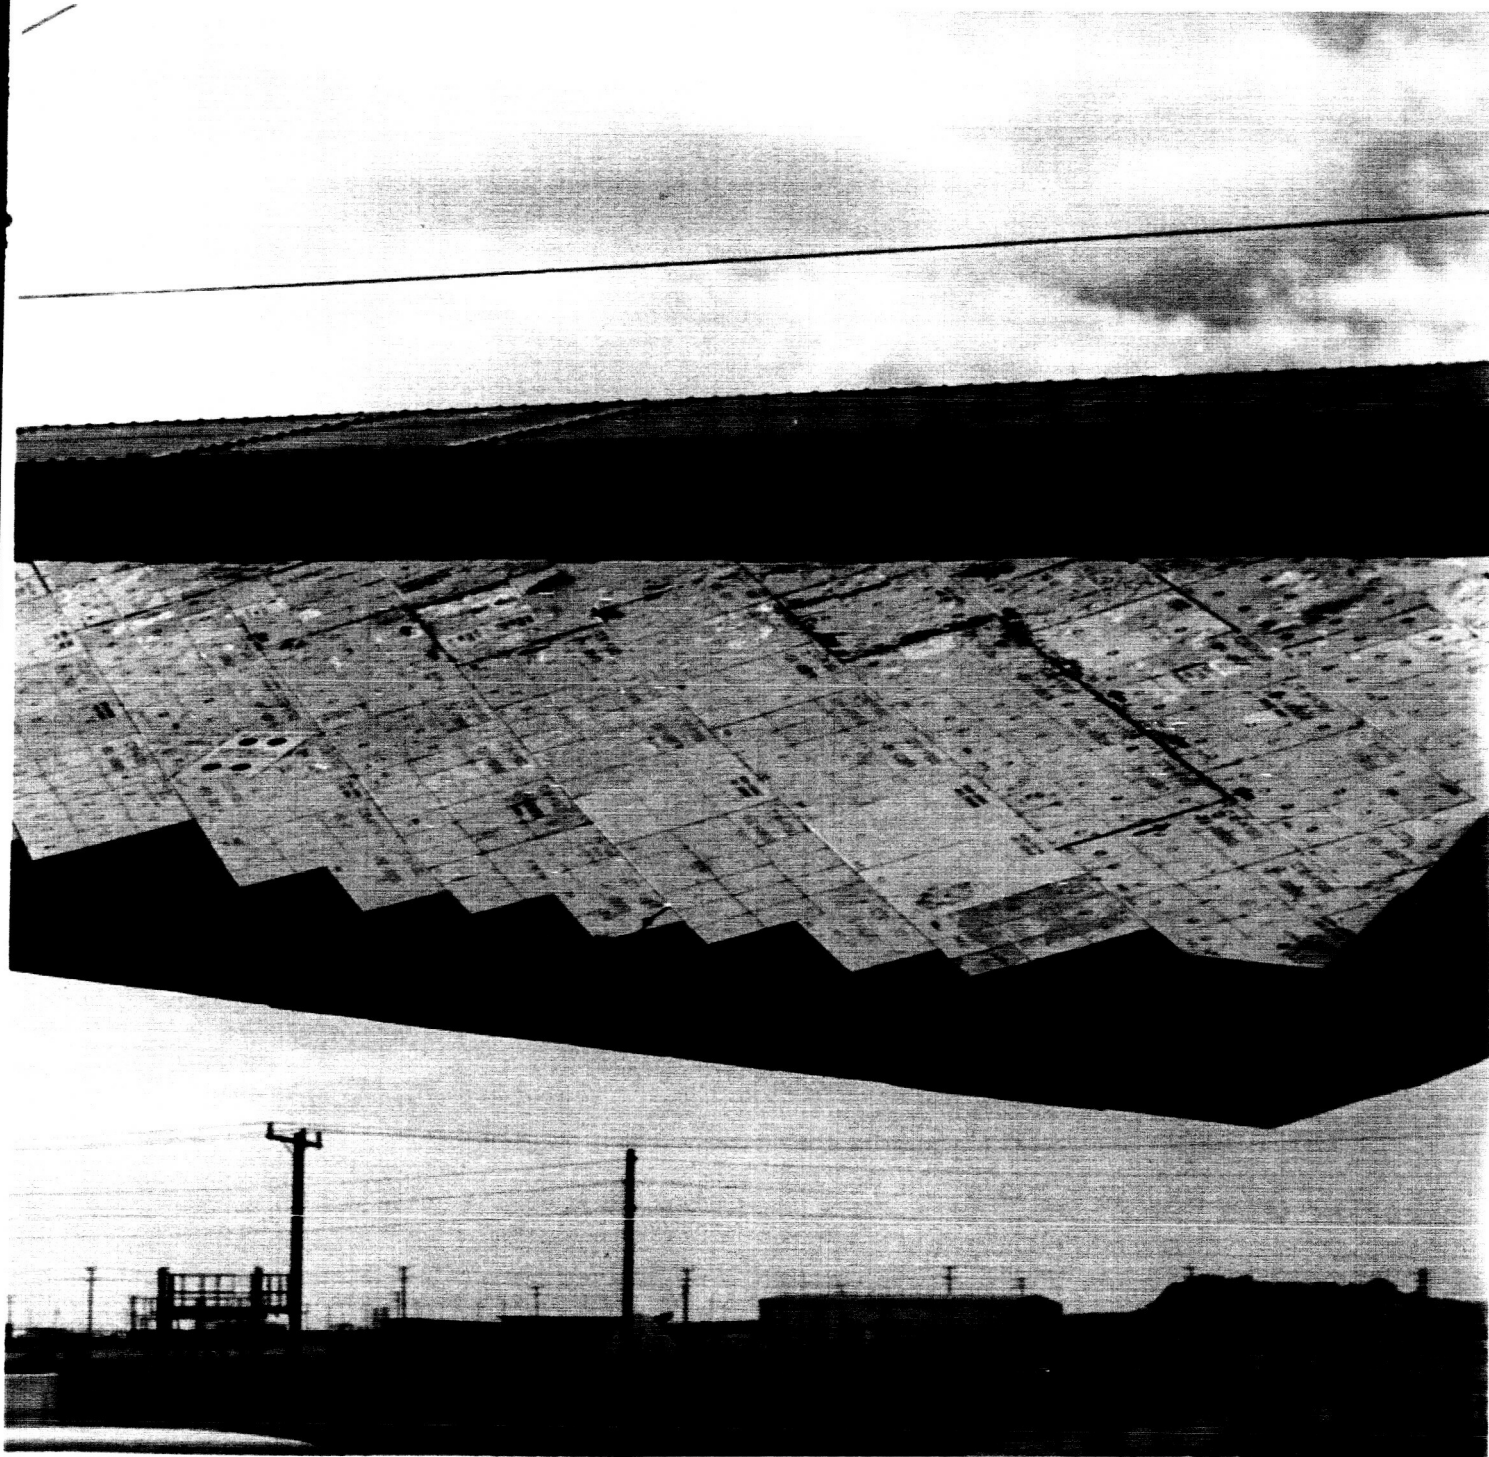
SSME ignition vibration/acoustics during launch caused pieces of tile material to shake loose from the elevon upper surfaces

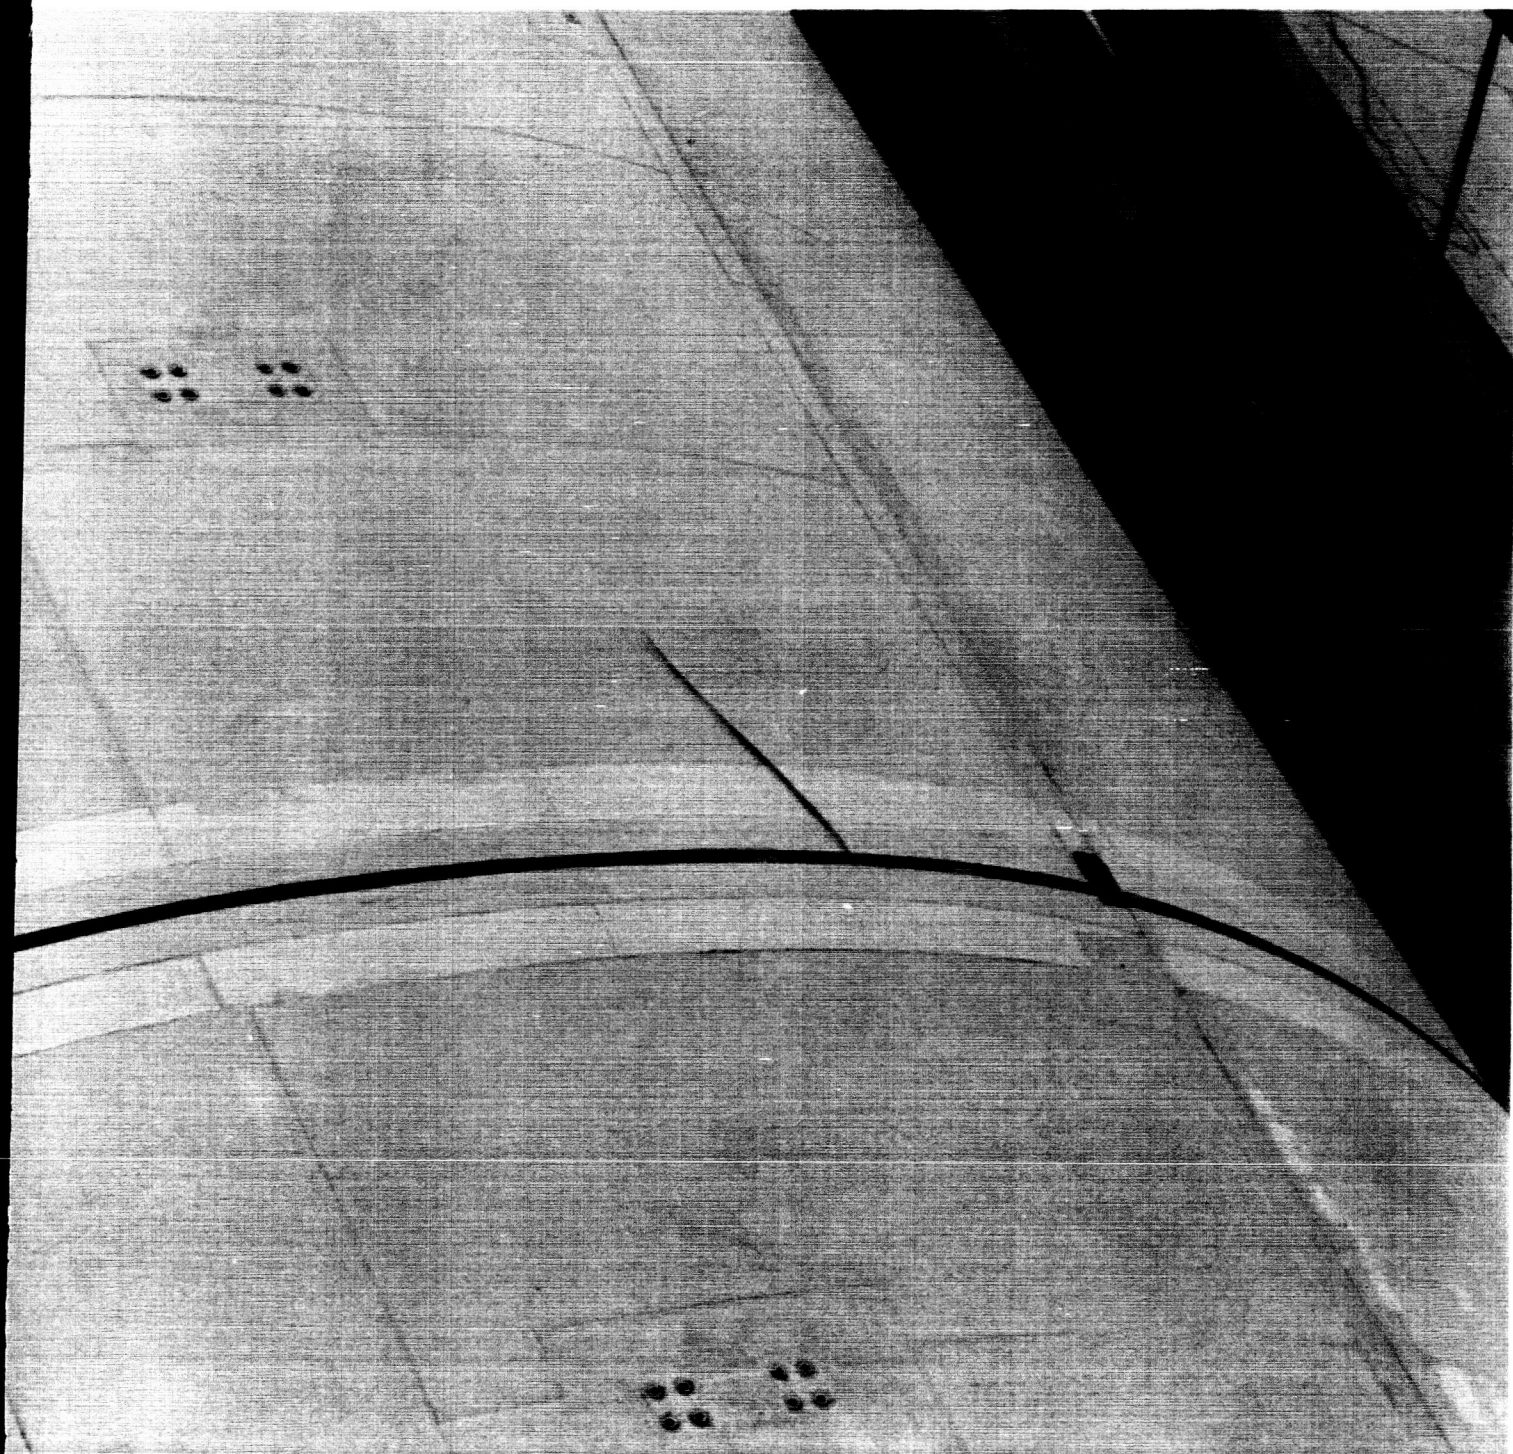
A 24-inch piece of seal material hung loosely from the joint
between the first/second sections of the RH payload bay door

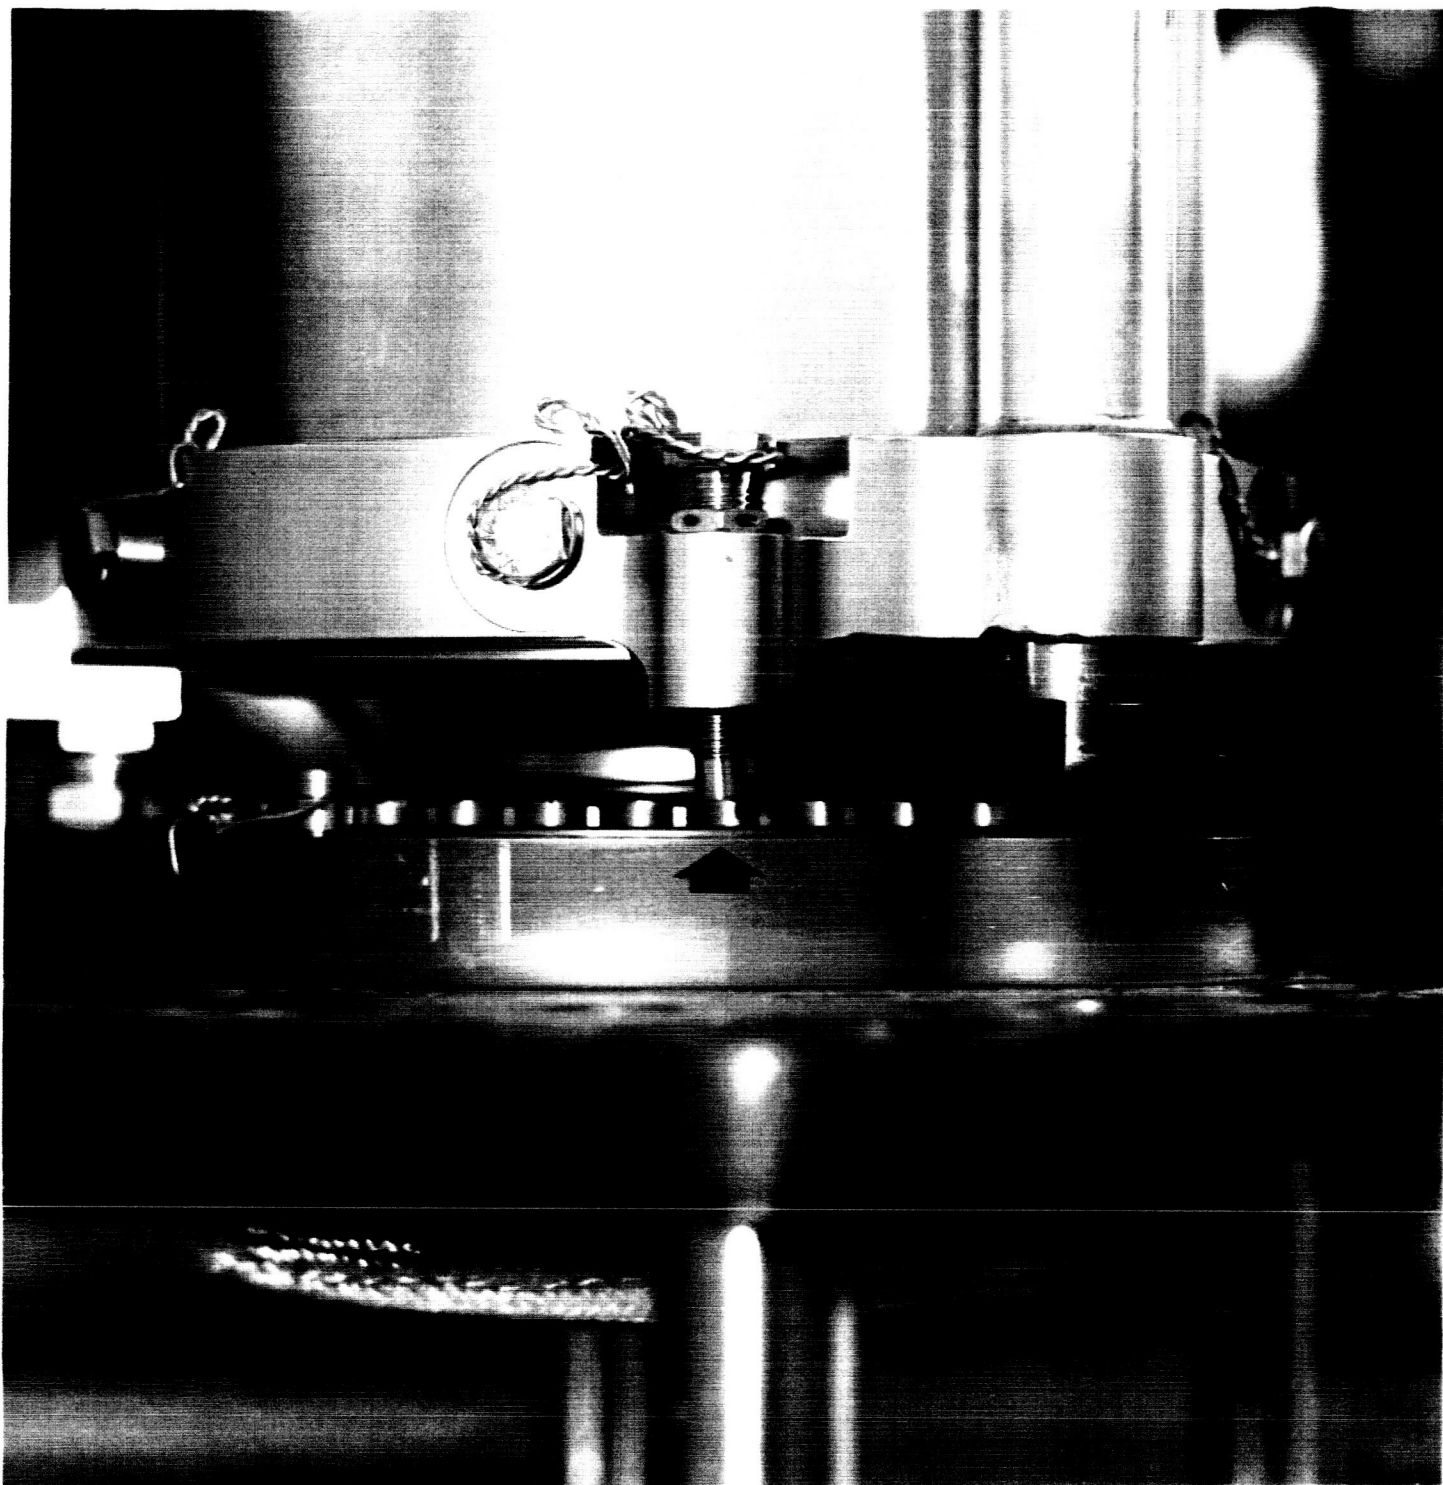
The EO-1 forward attach point separation device appeared to operate properly, though the RH stop bolt was bent
